**SAS Superstructure**

**Daily Diary Report by Bid Item**

Diary #: 007 Const Calendar Day: 161 Date: 16-Feb-2010 Tuesday

04-0120F4  
04-SF-80-13.2/13.9  
Self-Anchored  
Suspension Bridge

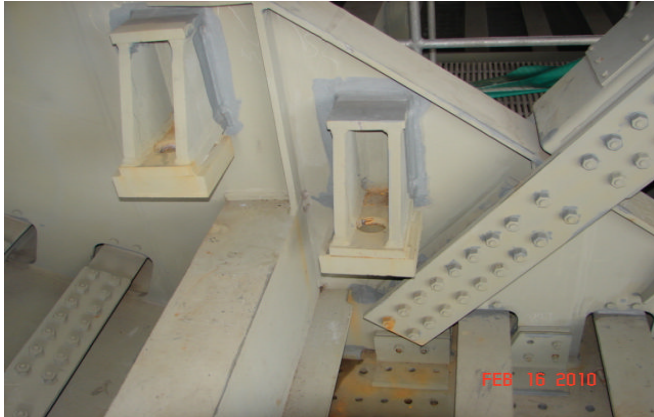
Lift 4W Lifting Lugs at PP27

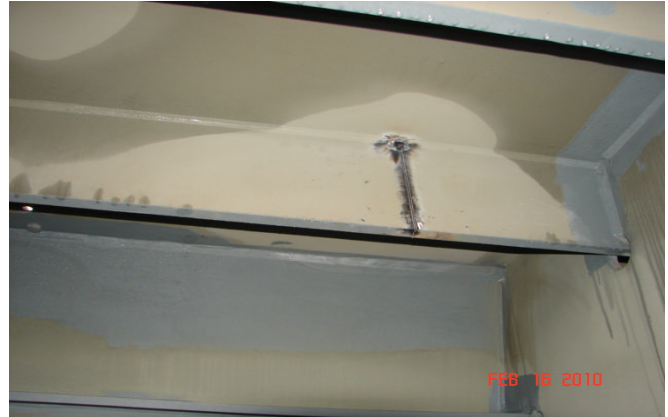
Lift 1W Access Hole cutting

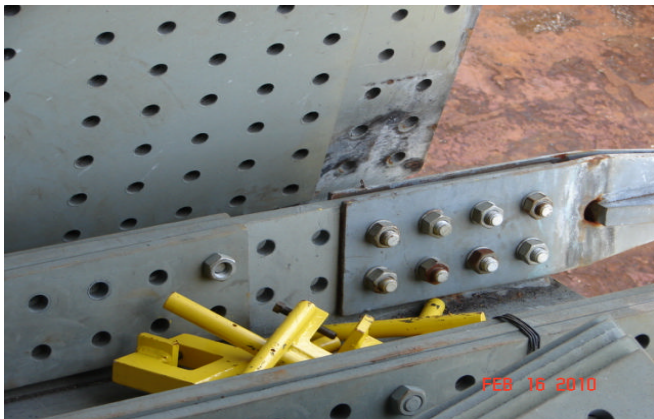
Lift 1W Longitudinal Bracing marks from sea fastening

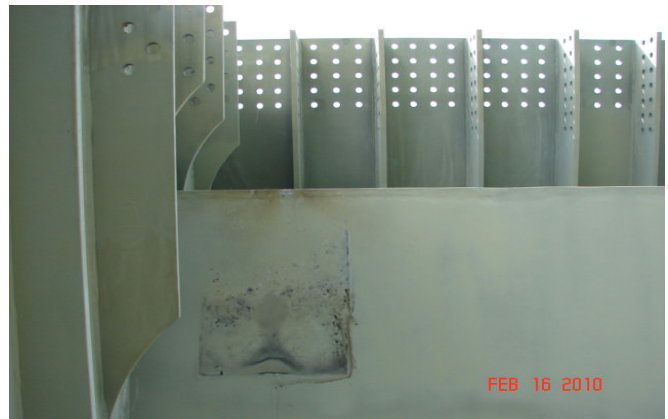
Lift 4W Crossbeam paint removed

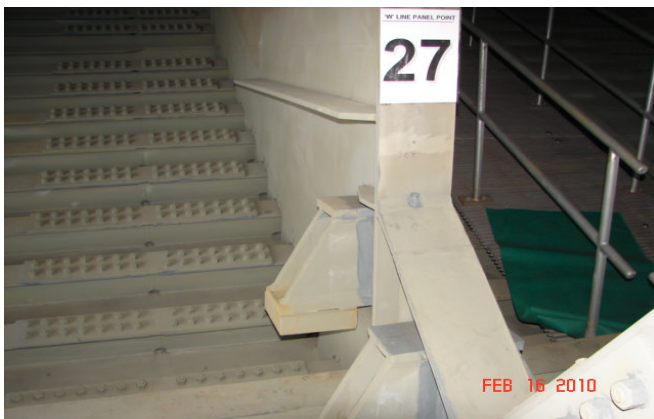
Lift 4W Lifting Rods removed at PP27
